**New York State Department of Transportation
Yellow Flag 1B19RPW008**

BIN: 3305810
Feature Carried: COUNTY ROAD 153
Feature Crossed: WHITE CREEK
Orientation: 3 - EAST
Region: 01 - ALBANY
County: WASHINGTON
Political Unit: Town of SALEM
Approximate Year Built: 1928
Posted Load Matches Inventory : N/A
Bridge Load Posting (Tons) : Not Posted for Load
Primary Owner: 30 - County
Primary Maintenance Responsibility: 30 - County
Typical or Main Span Type: A - Unpainted Steel, 02 - Stringer/Multi-Beam or Girder
This Bridge is not a Ramp
Number of Spans: 1

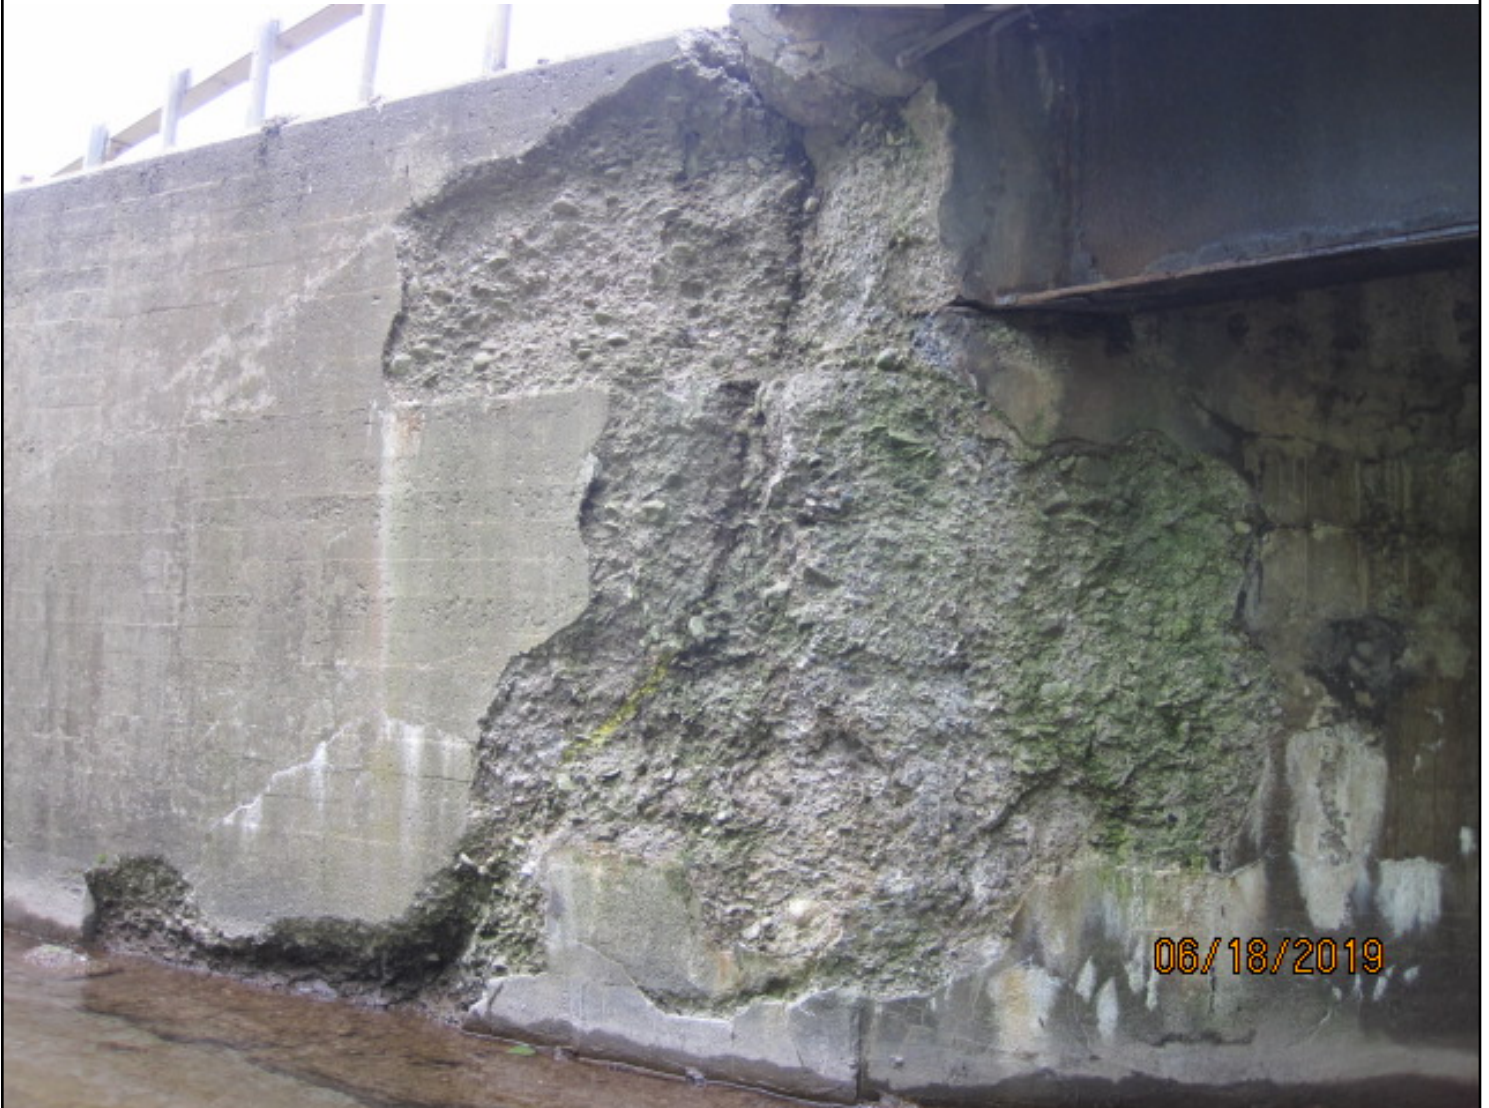
Photo Number: 1

Abutment / Wingwall is cracked, delaminated and spalled ove most of its surface. The spall is up to 16"L X full abutment height X up to 1"D; worst along the top 5' of the abutment, exposing original backwall at left edge of girder. Embedment depth is unknown, concrete cover to the left of left fascia girder is 1.5'W ft wide (measured perpendicularly from left web face) x 2.75'H x unknown depth. Embedment cover over left side of left fascia girder has cracks that run from both top and bottom flanges to left face of backwall and vertical crack. Bottom 6' of spall is less deep with a maximum spall depth of up to 6". Spall undermines left fascia girder for full-girder width x 6"H X up to 1"D; remaining concrete in this vicinity is sound. A crack runs adjacent to left fascia girder down diagonally through spall to footing. These conditions appear similar to the last inspection in 2018.

Attachment Description: End Left Abutment, Backwall and Pedestal

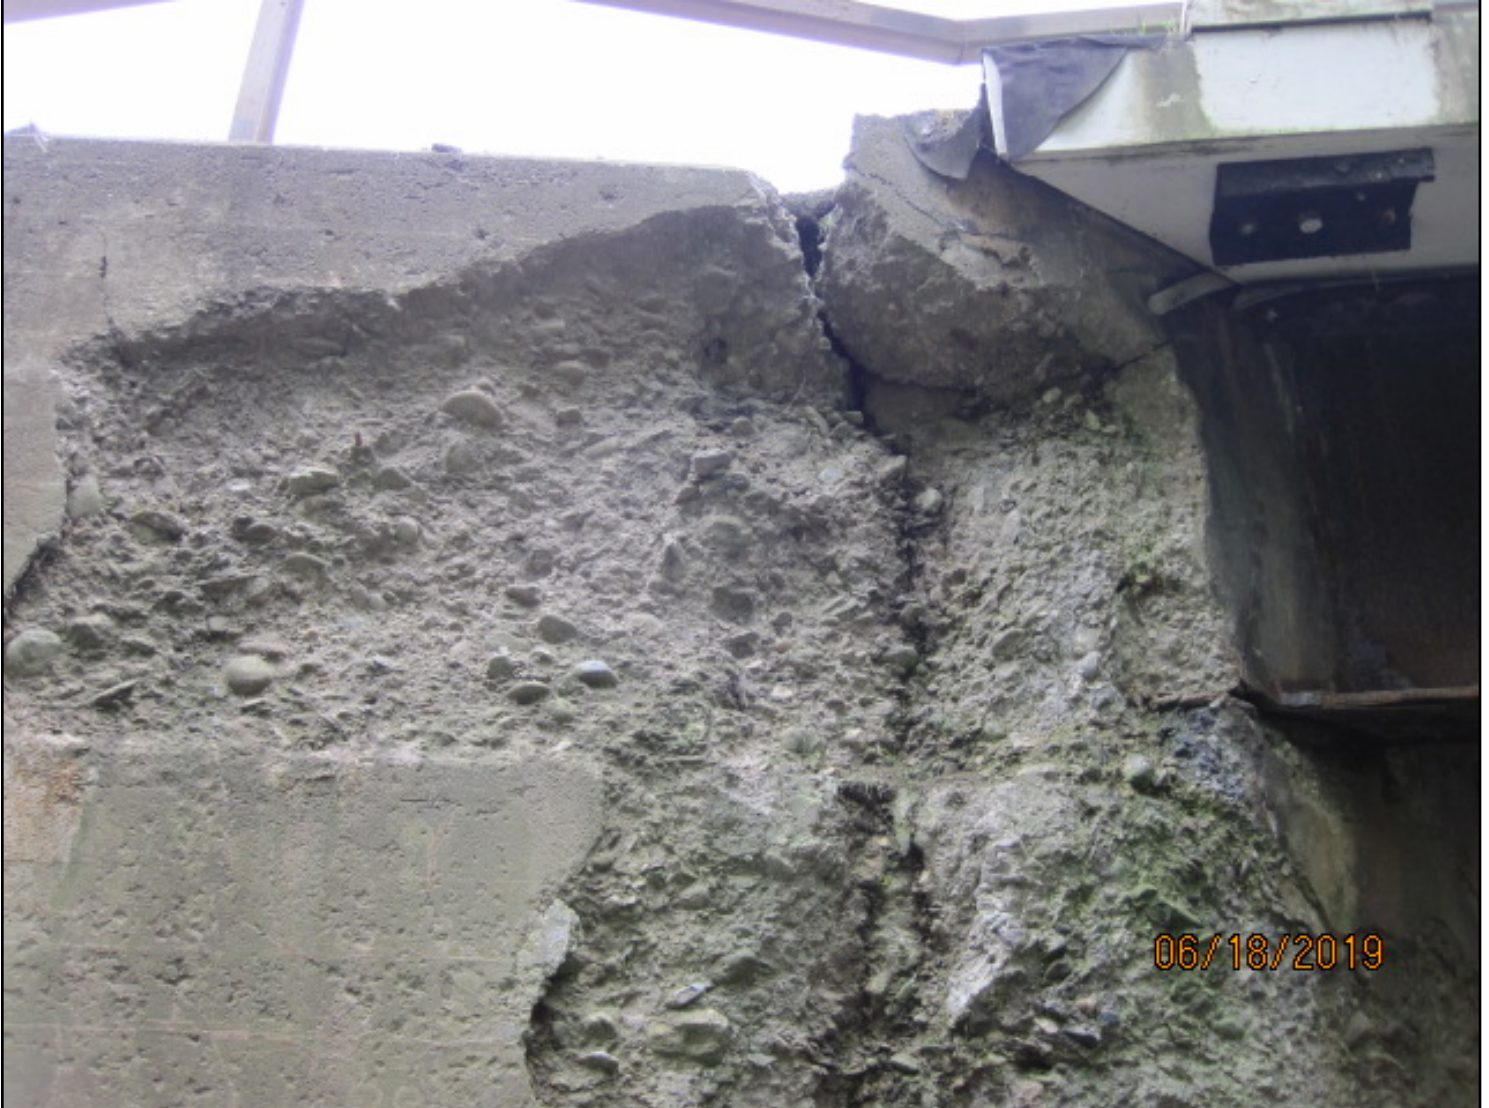
Photo Number: 2

Attachment Description: End Left Abutment, Backwall and Pedestal Close up

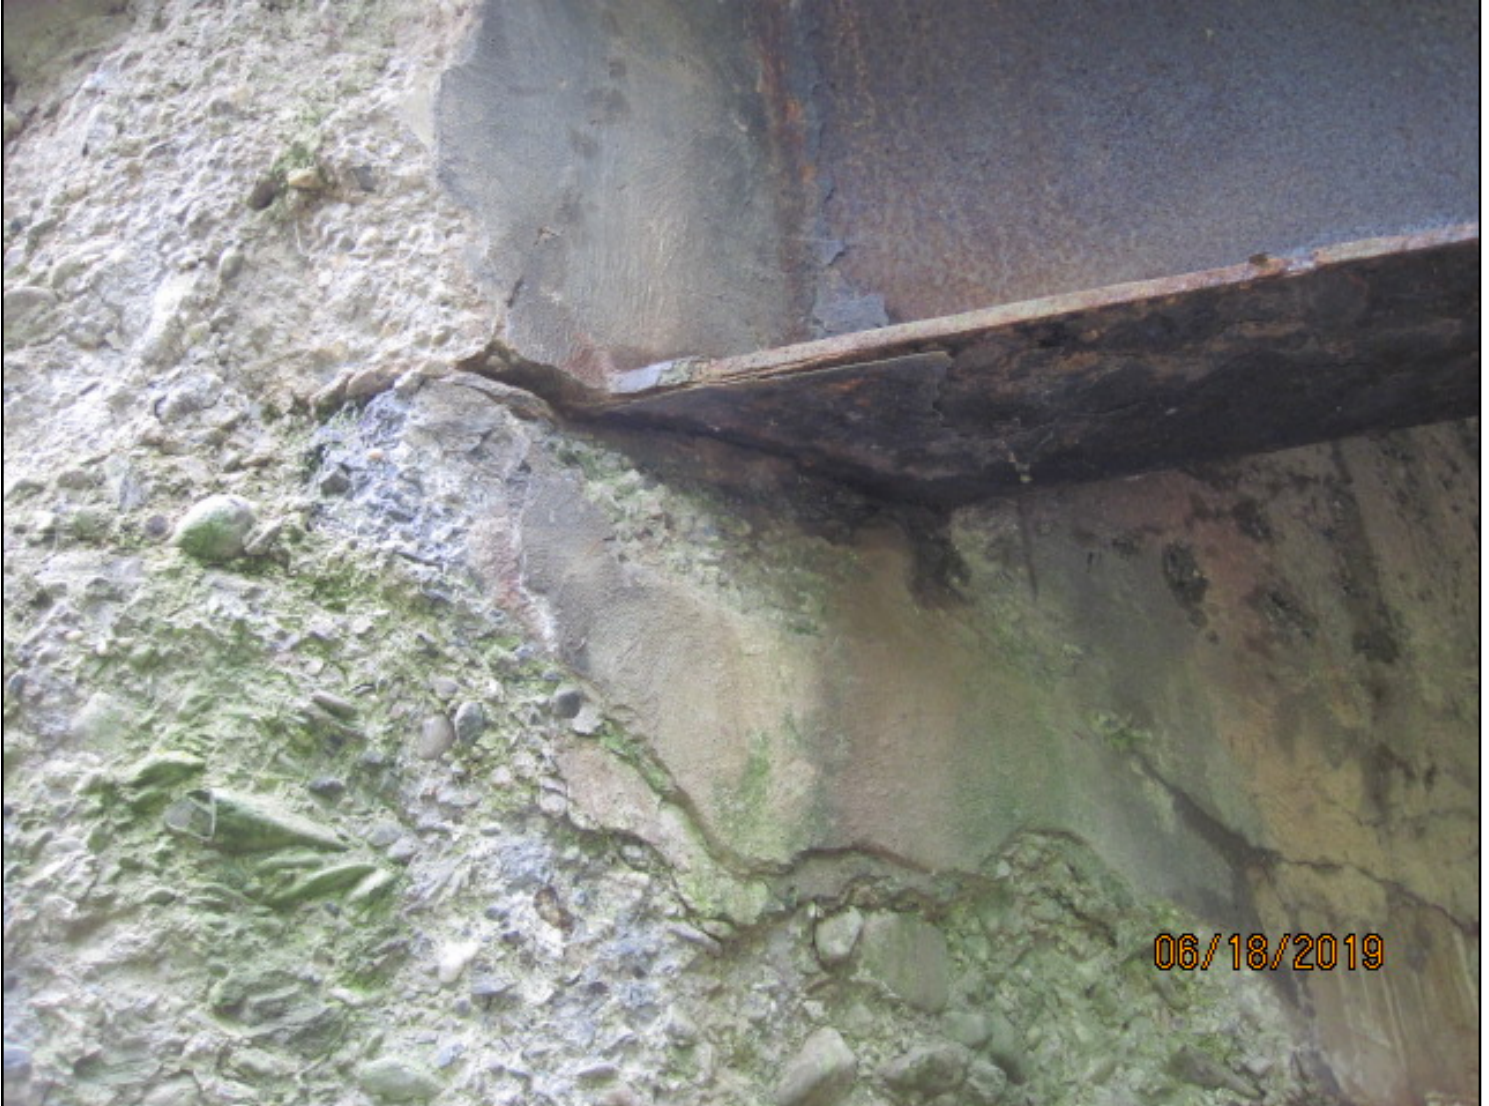
Photo Number: 3

Attachment Description: End Left Abutment and Pedestal

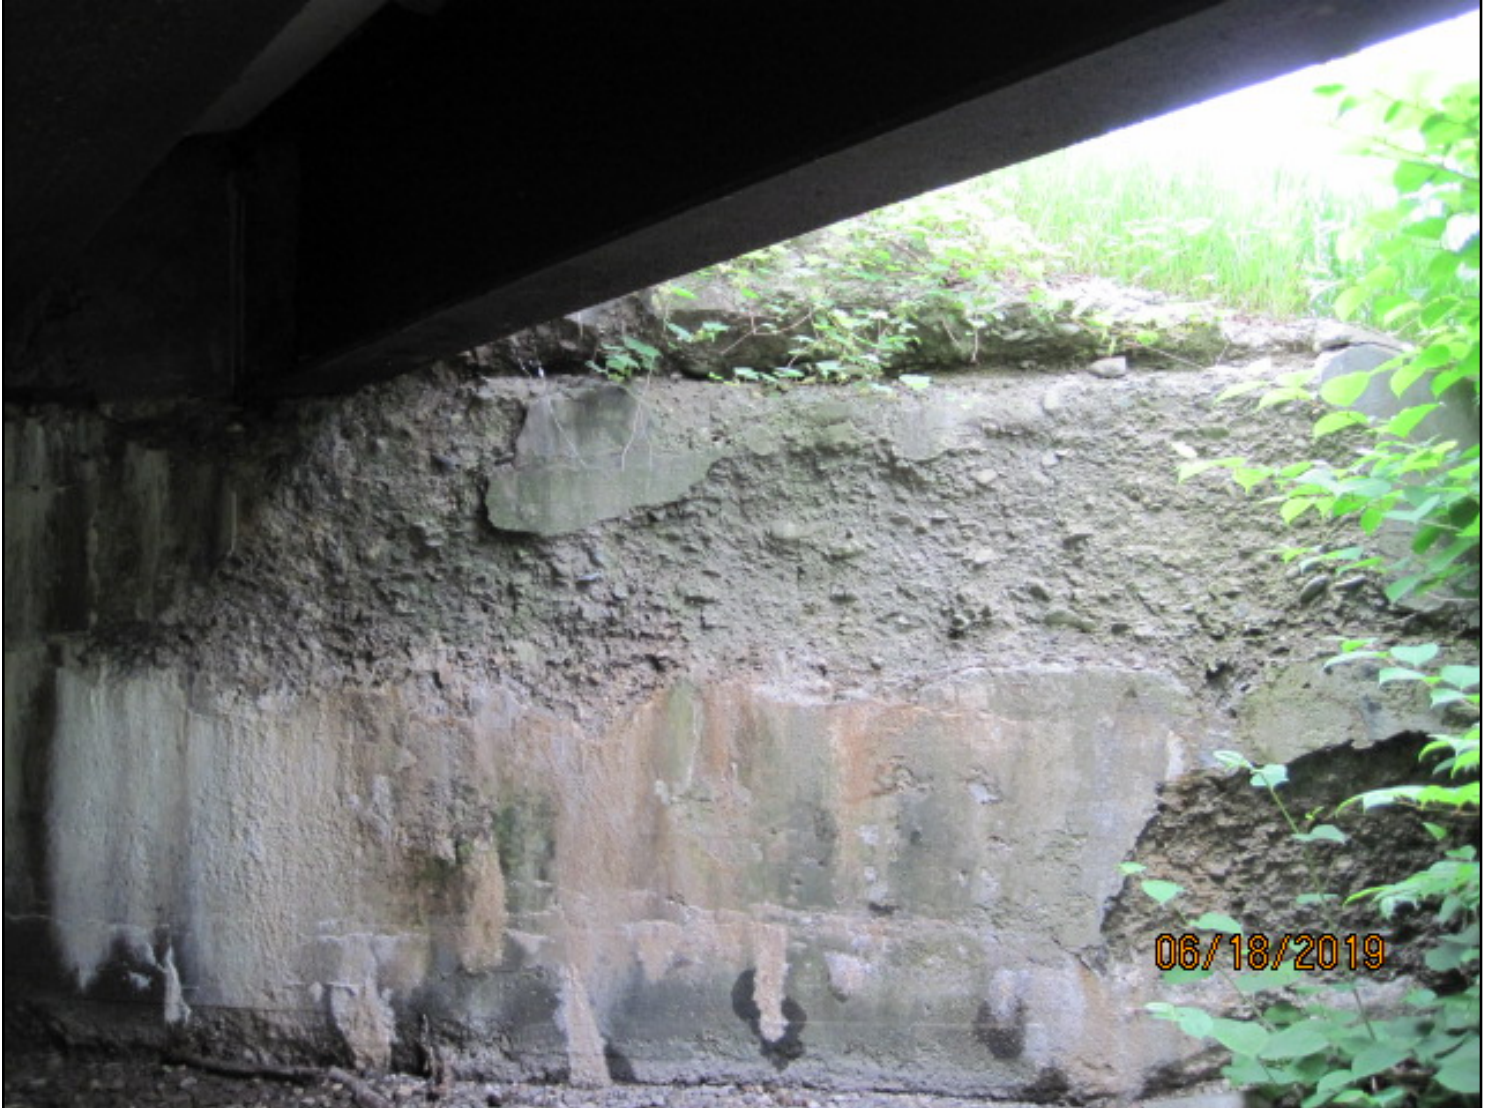
Photo Number: 4

Abutment / Wingwall is delaminated and spalled. Delaminations and spalls extend from under right fascia girder to end of abutment / wingwall. The spall is up to 18'L X 6'H X up to 8"D. Spall undermines right fascia girder for full girder width x3"D; remaining concrete in the vicinity is sound. Embedment length of Girders is unknown. These conditions appear similar to the last inspection in 2018.

Attachment Description: End Right Abutment and Pedestal

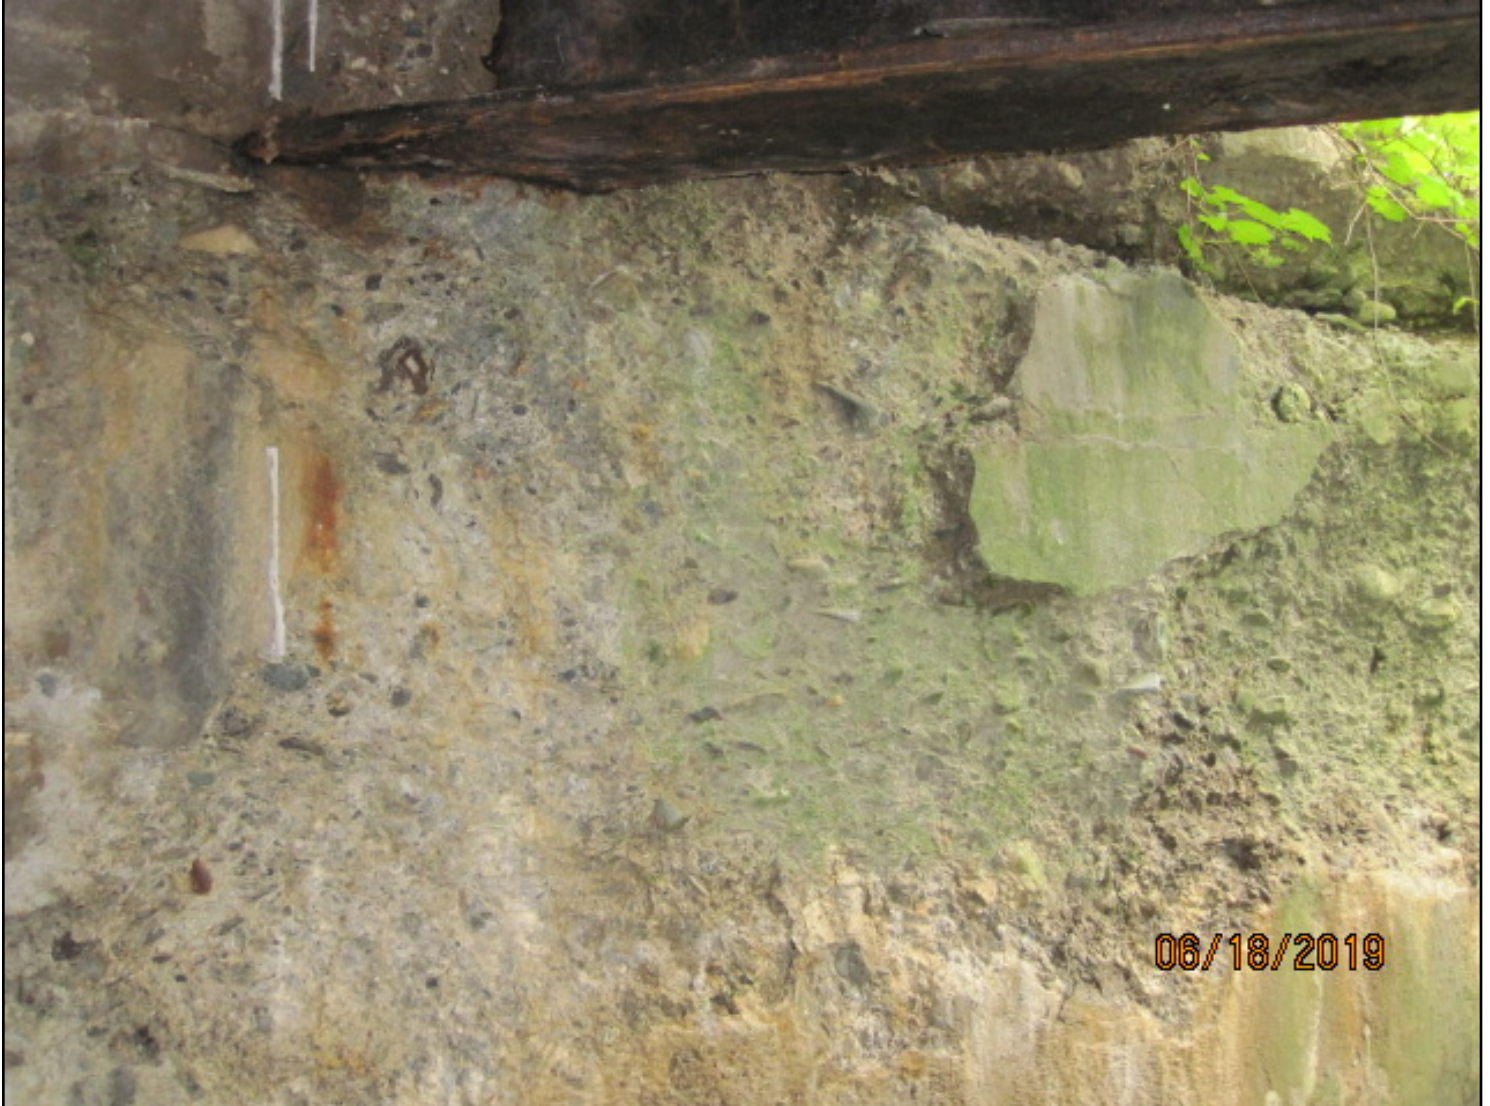
Photo Number: 5

Attachment Description: End Right Abutment, Backwall and Pedestal
